HOUSATONIC RIVER BASIN
SHARON, CONNECTICUT

**HATCH POND DAM
CT 00603**

**PHASE I INSPECTION REPORT
NATIONAL DAM INSPECTION PROGRAM**

SEPTEMBER 1980

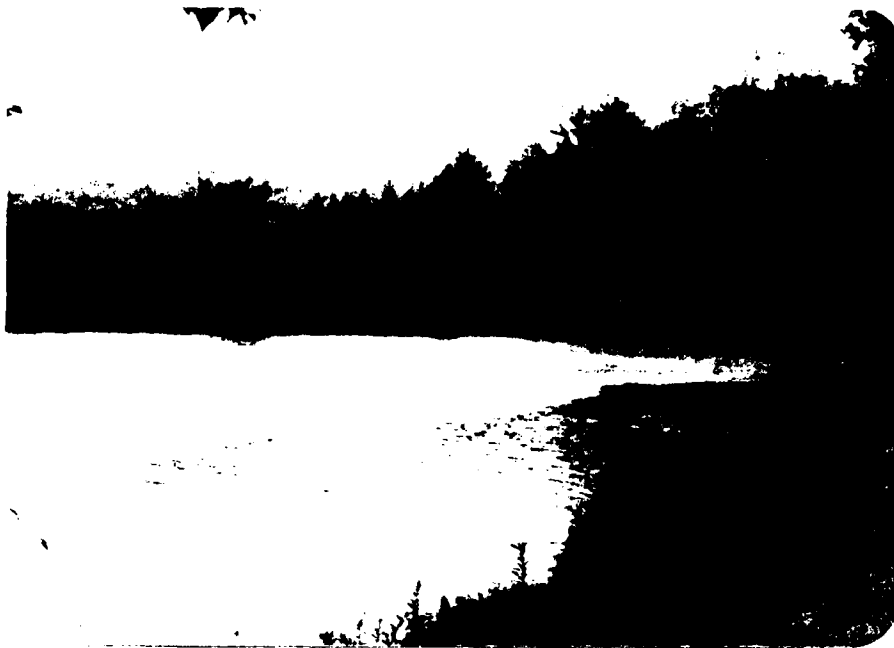
PHOTO NO. 1

The upstream slope of the dam is protected by riprap from below the water level to about 1 foot below the crest. The riprap appears to be in good condition but is heavily overgrown with weeds and brush, Photo 2. Several trees up to 3 inches in diameter are growing on the upstream slope near the center and right end of the dam, Photo 1.

VIEW OF DAM FROM RIGHT SIDE OF POND.
NOTE SERVICE BRIDGE OVER SPILLWAY AT
RIGHT AND VEGETATION ON UPSTREAM SLOPE AND CREST.

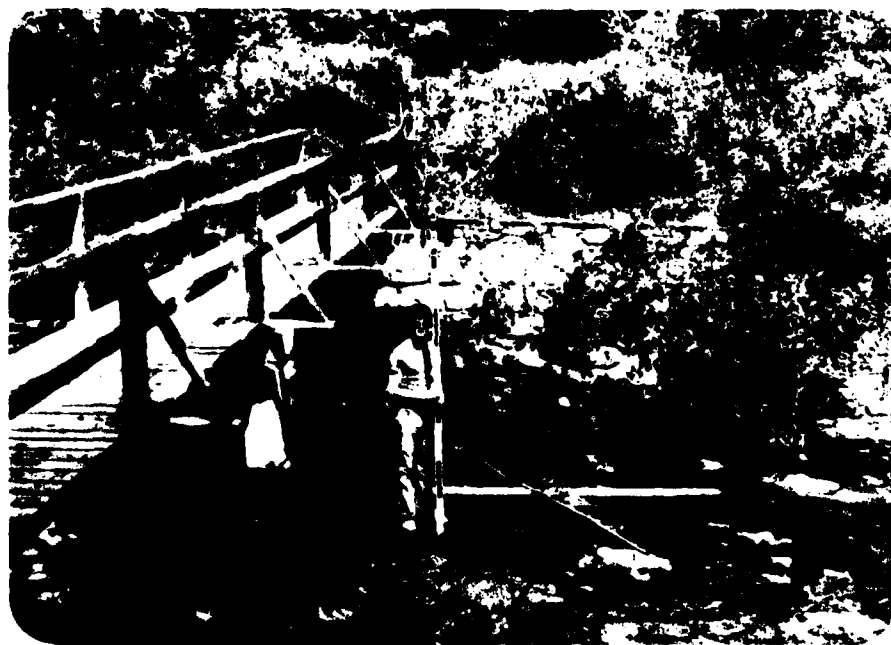
PHOTO NO. 6

The spillway located at the right end of the dam consists of a concrete overflow section with a mortared cut stone cap, Photo 6. The spillway appears to be in good condition. There is a slight amount of leakage under the cap stones. At the left end of the spillway there is an inclined flume approximately 2 feet wide and slightly lower in elevation than the remaining spillway crest, Photo 6. The upstream stone masonry training walls are overgrown with brush and vines and appear to be in good condition.

The service bridge over the spillway consists of a wooden footbridge supported by steel rails and a center stone pier, Photo 6. The bridge appears to be in good condition with the exception of a broken railing and possible tilting of the center pier.

SPILLWAY FROM
RIGHT ABUTMENT.
NOTE FLUME AT LEFT
END OF SPILLWAY
AND SERVICE BRIDGE.

8. Repair footbridge railing and center pier.

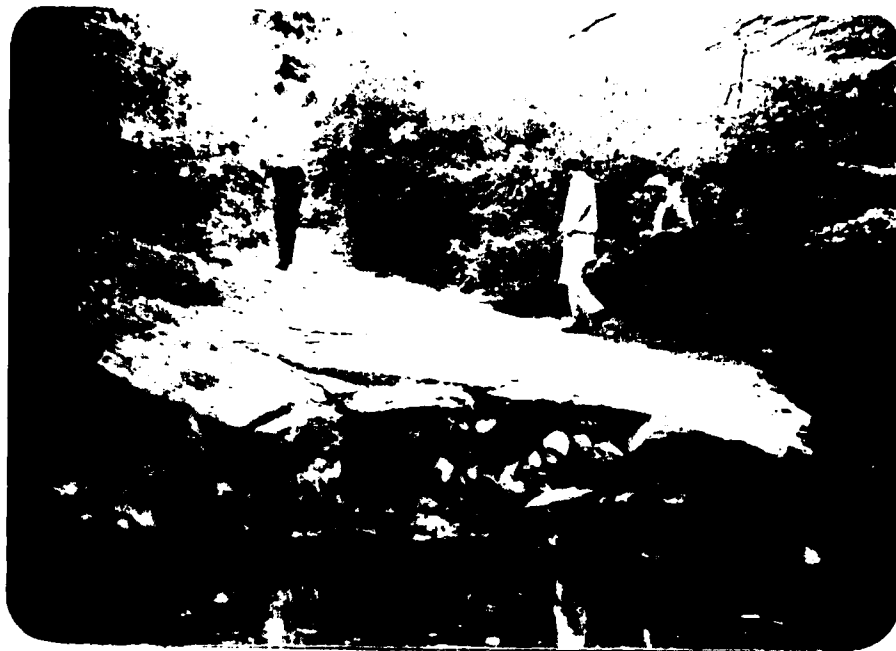
PHOTO NO. 9

a wood sheet pile cutoff below the bottom of the channel, Photo 8. The end of the channel has been undermined and is badly broken, Photo 9.

UNDERMINING AND
DETERIORATION AT
END OF SPILLWAY
DISCHARGE CHANNEL.

5. Investigate and recommend procedures to prevent further undermining of the lower end of the spillway discharge channel.
6. Perform a detailed hydraulic and hydrologic analysis in order to determine the need for and means to provide additional project discharge capacity.
